FARMERS' BULLETIN No. 1315

**CLEANING** MILKING **MACHINES**

By L. H. Burgwald, Associate Market-Milk Specialist, Division of Market-Milk Investigations, Bureau of Dairy Industry

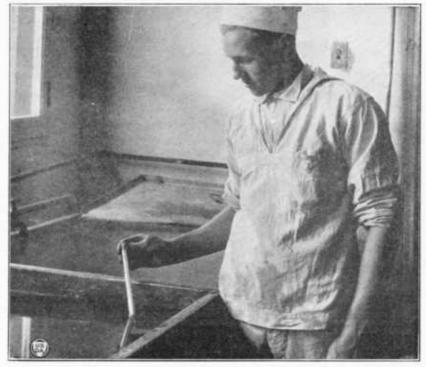
FIGURE 4.—The water is then heated, preferably with steam, to a temperature of from 160 to 165° F, and then allowed to cool and the parts to remain there until the next milking. A covered tank is preferable

Experiments were carried on by the department on the length of life of the rubber parts when the heat method was used. This consists in placing the unit (teat cups, claw and tubing) in hot water at a temperature of 160° to 165° F. between milkings, the water cooling gradually. The average length of life of the teat-cup liners was about 13 weeks. The short rubber milk tubes lasted about 24 weeks, and the short air tubes and long milk tube lasted for nearly 31 weeks.

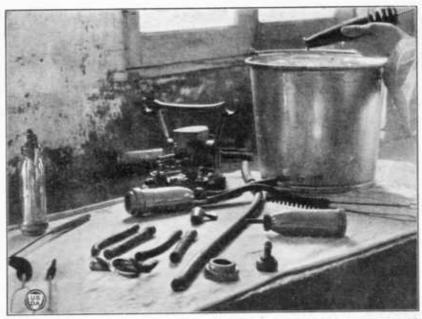
Figure 7.—The machines should be taken entirely apart and washed thoroughly with brushes and hot water containing washing powder

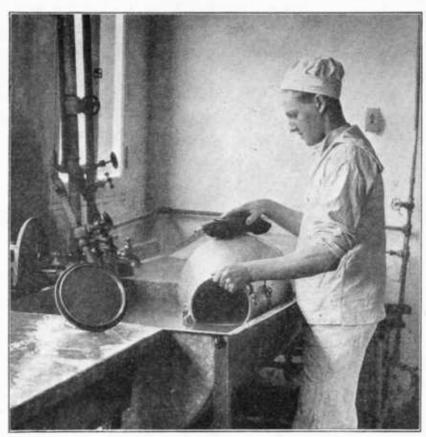
Figure 9.—Milking-machine pails and covers should be thoroughly washed after every milking and then treated to kill bacteria

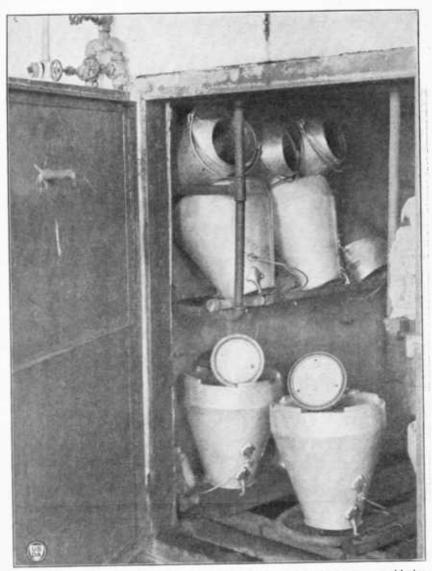
Figure 10.—Milking-machine pails and covers should be treated with steam or a chlorine solution. Pulsators and electric motor should be removed before such treatment
